A report on the state of knowledge
about the
Charnel House, Crypt and Nave Burials
in
Saint Mary's Church, Bridgwater
for
Mark Richmond
and the Reordering Committee

By
Tony Woolrich
10 June 2011

REPORT

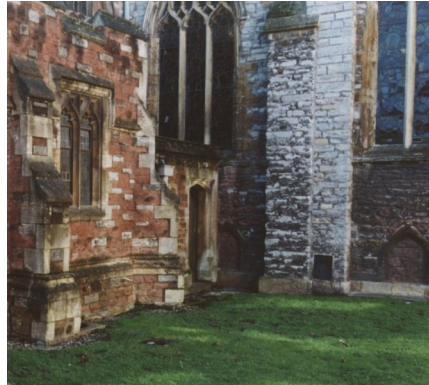
The charnel house had its origins in the fourteenth century and in 1420 the churchwardens' accounts record much work to lower the stone floor and construct a wooden floor over the void. (SRO 1938, No 475) It was used to house bones found when making new graves in the churchyard and in the body of the church. In 1420 a man worked for 5 ½ days, at a cost of 1s 10d, to remove the bones for burial elsewhere. (Ibid) The two low arches in the eastern wall of the transept overlooking the grass are undoubtedly blocked-off ventilation holes to draw off the smell of disinterred bones. Fig 1

Fig 1 Vents low in the east wall of the Transept

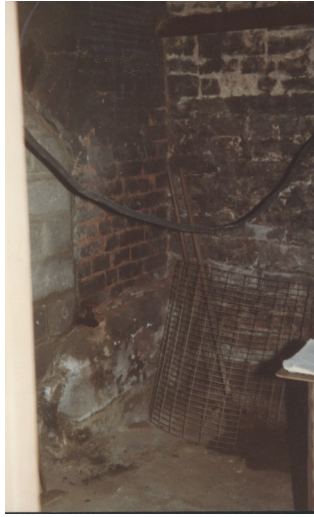
The charnel house is under the north transept, at the eastern end, and now houses the heating boiler and oil tank. The crypt's extent is not now known, for an entrance from the charnel house was blocked off many years ago. Figs 2 and 3 (Verbal communication from Frances Pearce and Decima Harper). Steps to it were reputed to lie in the vicinity of one of the niches in the north aisle. (Jarman, 1885, p 6) Part of the crypt is reputed to lie under the western end of the north transept (Conibere, Pearce and Woolrich, c2000 p. 9). The crypt was reputed to have been stopped being used for its proper purpose and to have been filled with concrete early in the nineteenth century. (Powell, 1906, p 114) Whether this formed part of Brakspeare's work is not known, but he did remove the wall dividing into two the transept which contained the famous squint, substituting a pair of pillars. See the drawing of the medieval layout. Before this was done the floor between the porch and the squint wall was rubble stone. (Jarman, 1885, p 8)

Fig 2 Blocked off passage way on the charnel house

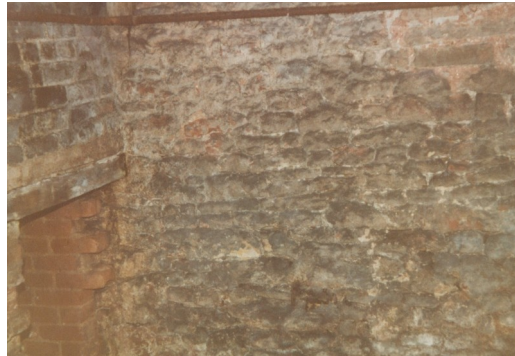
Fig 3 Early stonework in the charnel house

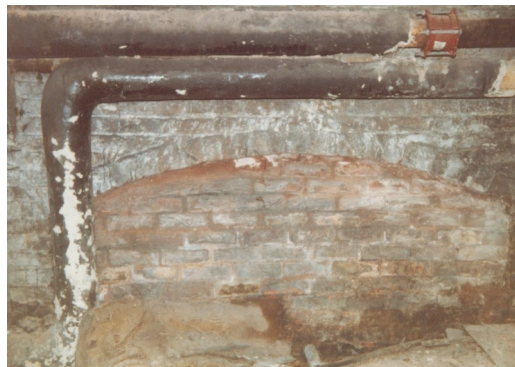
Fig 4 Blocked arch by the boiler in the charnel house

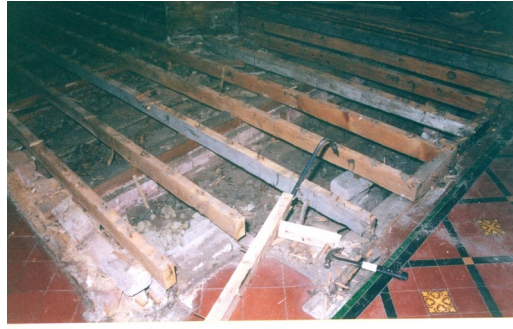
The photographs taken when the pews were removed in 1996 and 2000 clearly show the construction of the pew bases. Shallow brick walls, some four or five courses thick were the built the length of the church from east to west at perhaps six to eight ft intervals. These may be the bases of the box pews. On these were placed longitudinal bearer timbers. At right angles to these were joists and on top of these were the pew-base floor boards. Fig 5 The 2000 photograph of the work by the north door clearly shows the Axford slab cut back to make room for the brick wall. Figs 10 and 11. The 1996 work shows no complete grave slabs, but a number of what appear to be fragments of them. Whether they were destroyed in Brakspear's time or earlier is not known.

Fig 5 Bearers and joists under the pews in the south block

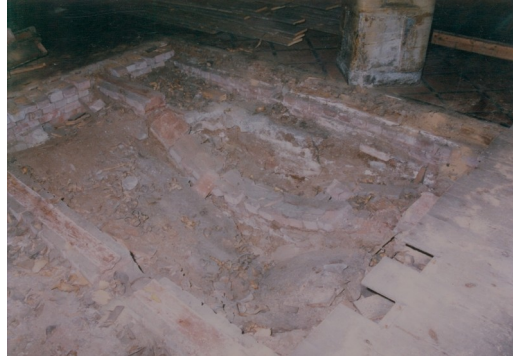
During the recent removal of some of the pews and re-tiling the floor several graves have been uncovered. In 1967 when two rows of pews were removed to the East of the nave, one such grave was found in the vicinity of the organ screen with the remains of Revd Wollen (vicar 1786-1844) and his daughters. Wollen's coffin was covered in fragments of black velvet. (Conibere, Pearce and Woolrich, c 2000, p14) In 1996 when five rows of pews were taken out for the nave altar at least one grave vault was found with wrecked coffin. Figs 7, 8 and 9. This was to the east of the north pillar. The brick pew support by the south pillar showed signs of subsidence indicating a collapsed vault beneath. Fig 6. By 2000, when two rows of pews were taken out by the North door, a damaged

Fig 6 Collapsed brickwork in south block

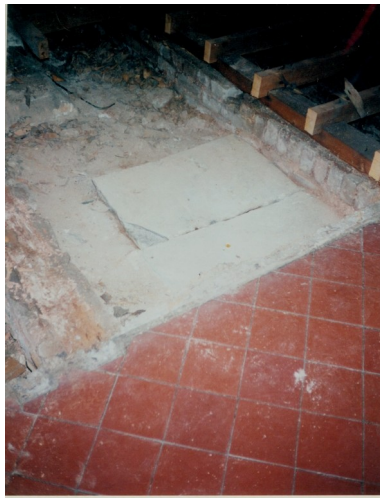
Fig 7 Slabs covering the burial vault in the north block

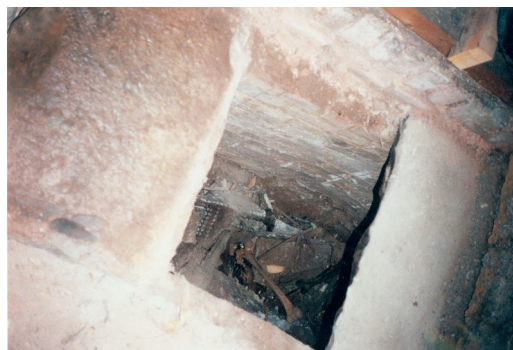
Fig 8 Coffin and remain in vault in north block

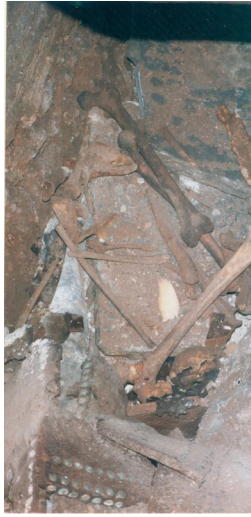
Fig 9 Lead coffin in north block

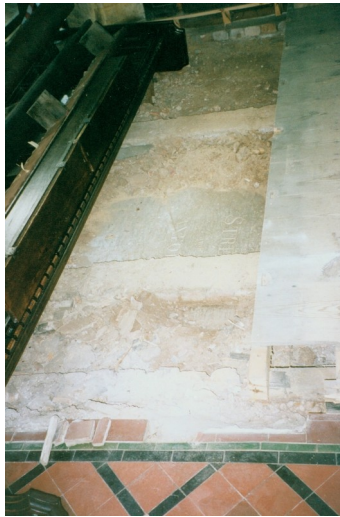
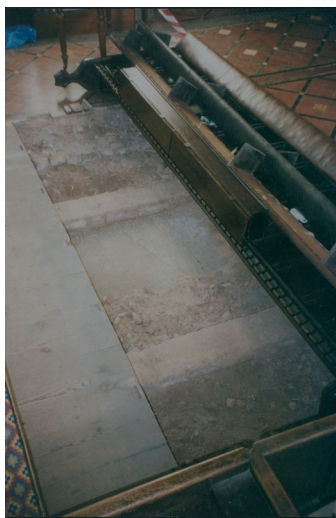
ledger stone with Axford on it was exposed. Figs 10 and 11. It is not known if there was a vault. In 2001 when the pews were removed by the font, graves were found but no details have yet been discovered. It is not known if any archaeological investigation and report was ever carried out for any of this work.

Fig 10 Axford grave slab by north door

Fig 11 Axford grave slab by north door
